AMMRC CTR 74-26

BRITTLE MATERIALS DESIGN, HIGH TEMPERATURE GAS TURBINE

Interim Report Number 5, July 1, 1973 to December 31, 1973

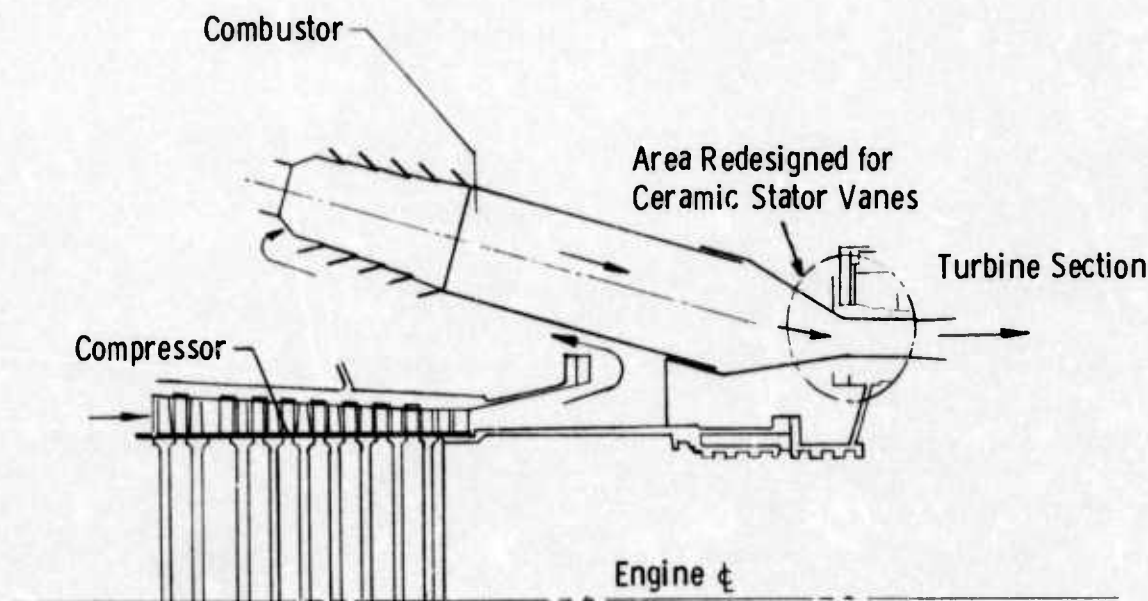
Figure 1.2 - 30 Mw Test Turbine Flow Path

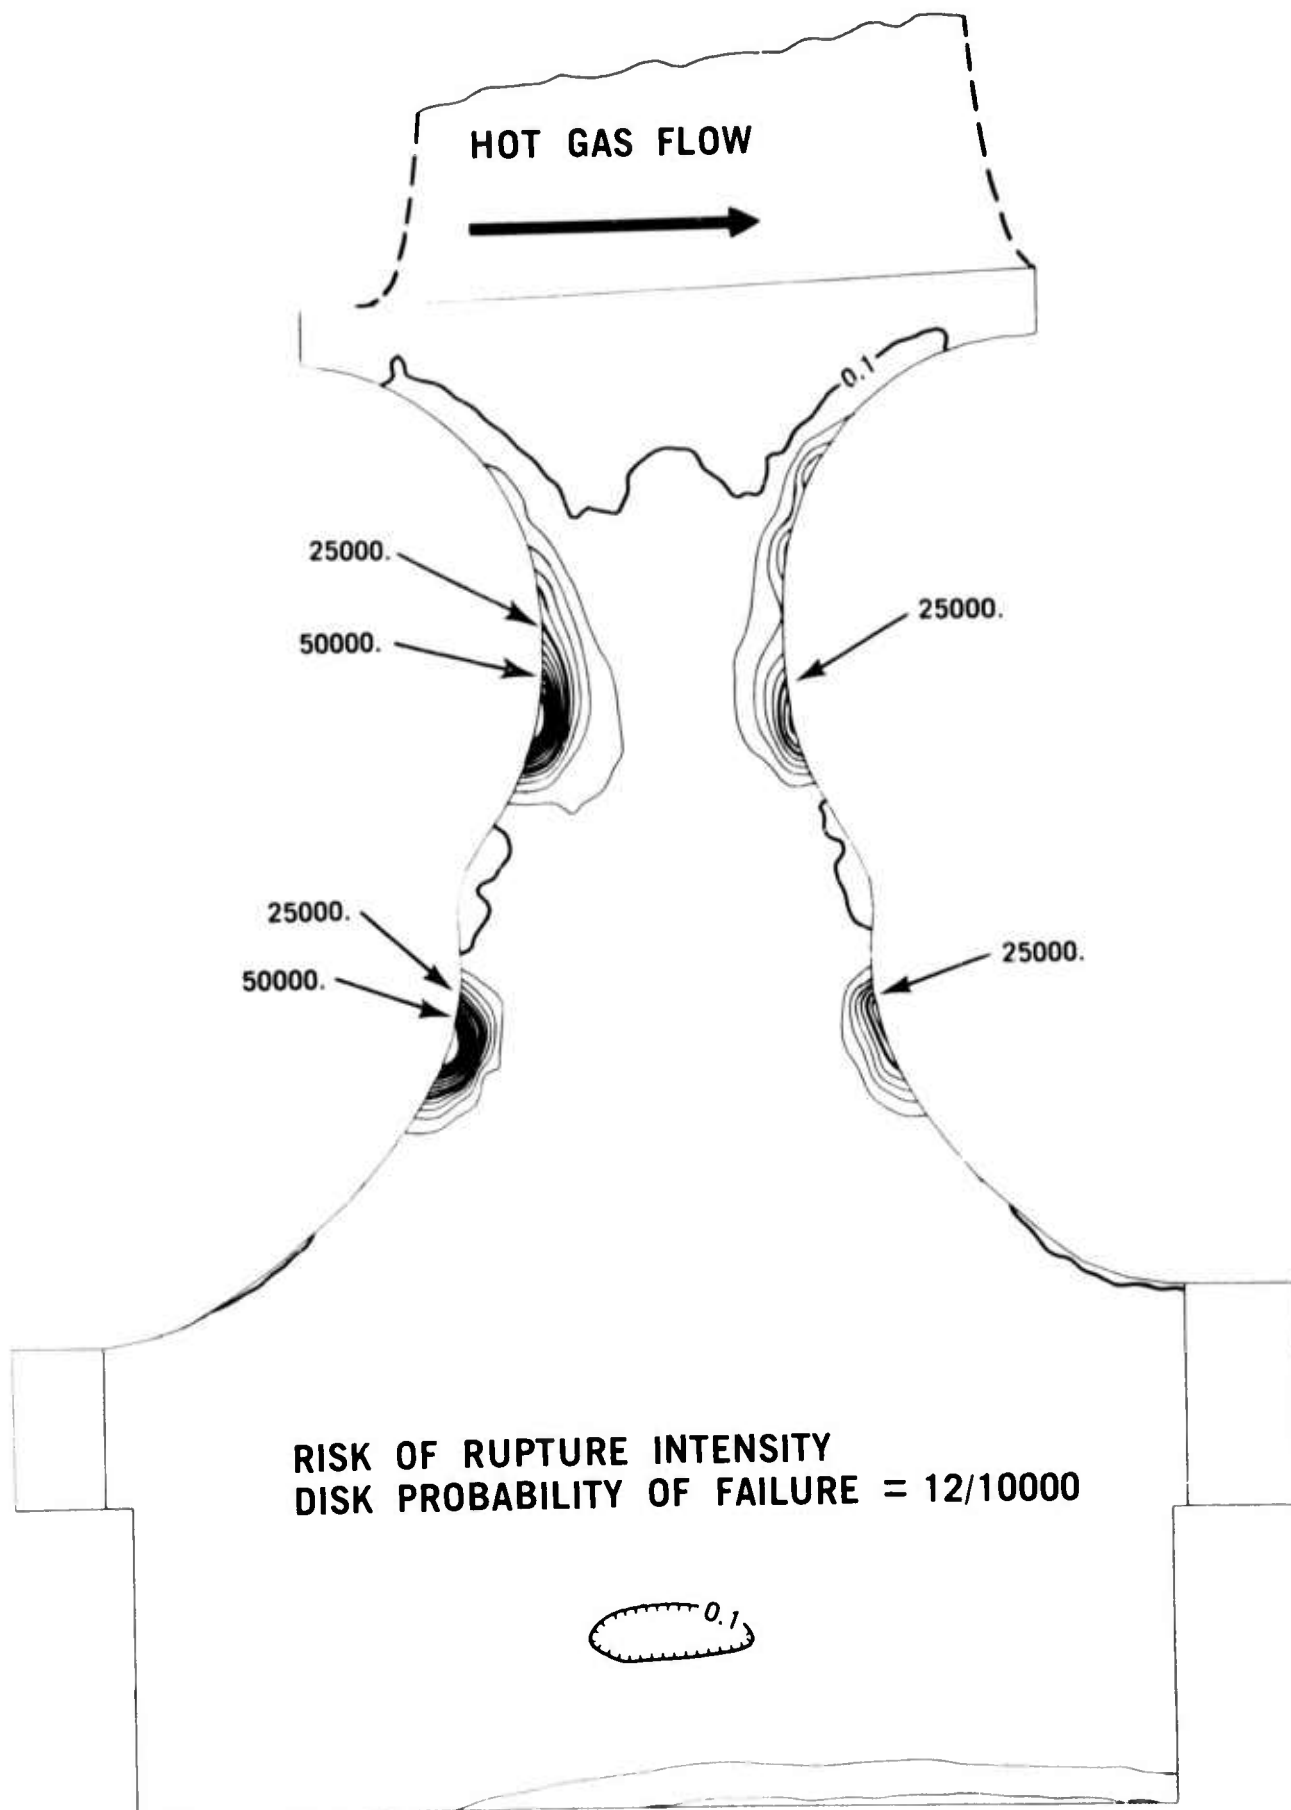
Figure 3.1a First Stage Rotor Risk of Rupture Intensity Map
For The Maximum Steady State Condition

The risk of rupture intensity contour maps for the first stage turbine rotor at maximum steady-state and two transient operating conditions are shown in Figures 3.1a, 3.2a, and 3.3a. These three conditions have been used in work reported earlier ⁽⁴⁾ to evaluate the rotor design. The maximum steady-state condition corresponds to full throttle operation and the two transients correspond to cold start and cold engine acceleration respectively. The cold start or first transient, as it is referred to throughout the remainder of this section, assumes the engine initially to be shutdown and at room temperature. The rotor blades are suddenly subjected to a hot gas stream and a rotational speed corresponding to the partial power output conditions. At maximum stress during this transient, the engine operating conditions are suddenly increased to full power. This represents full throttle acceleration of a cold engine and is termed the second transient.

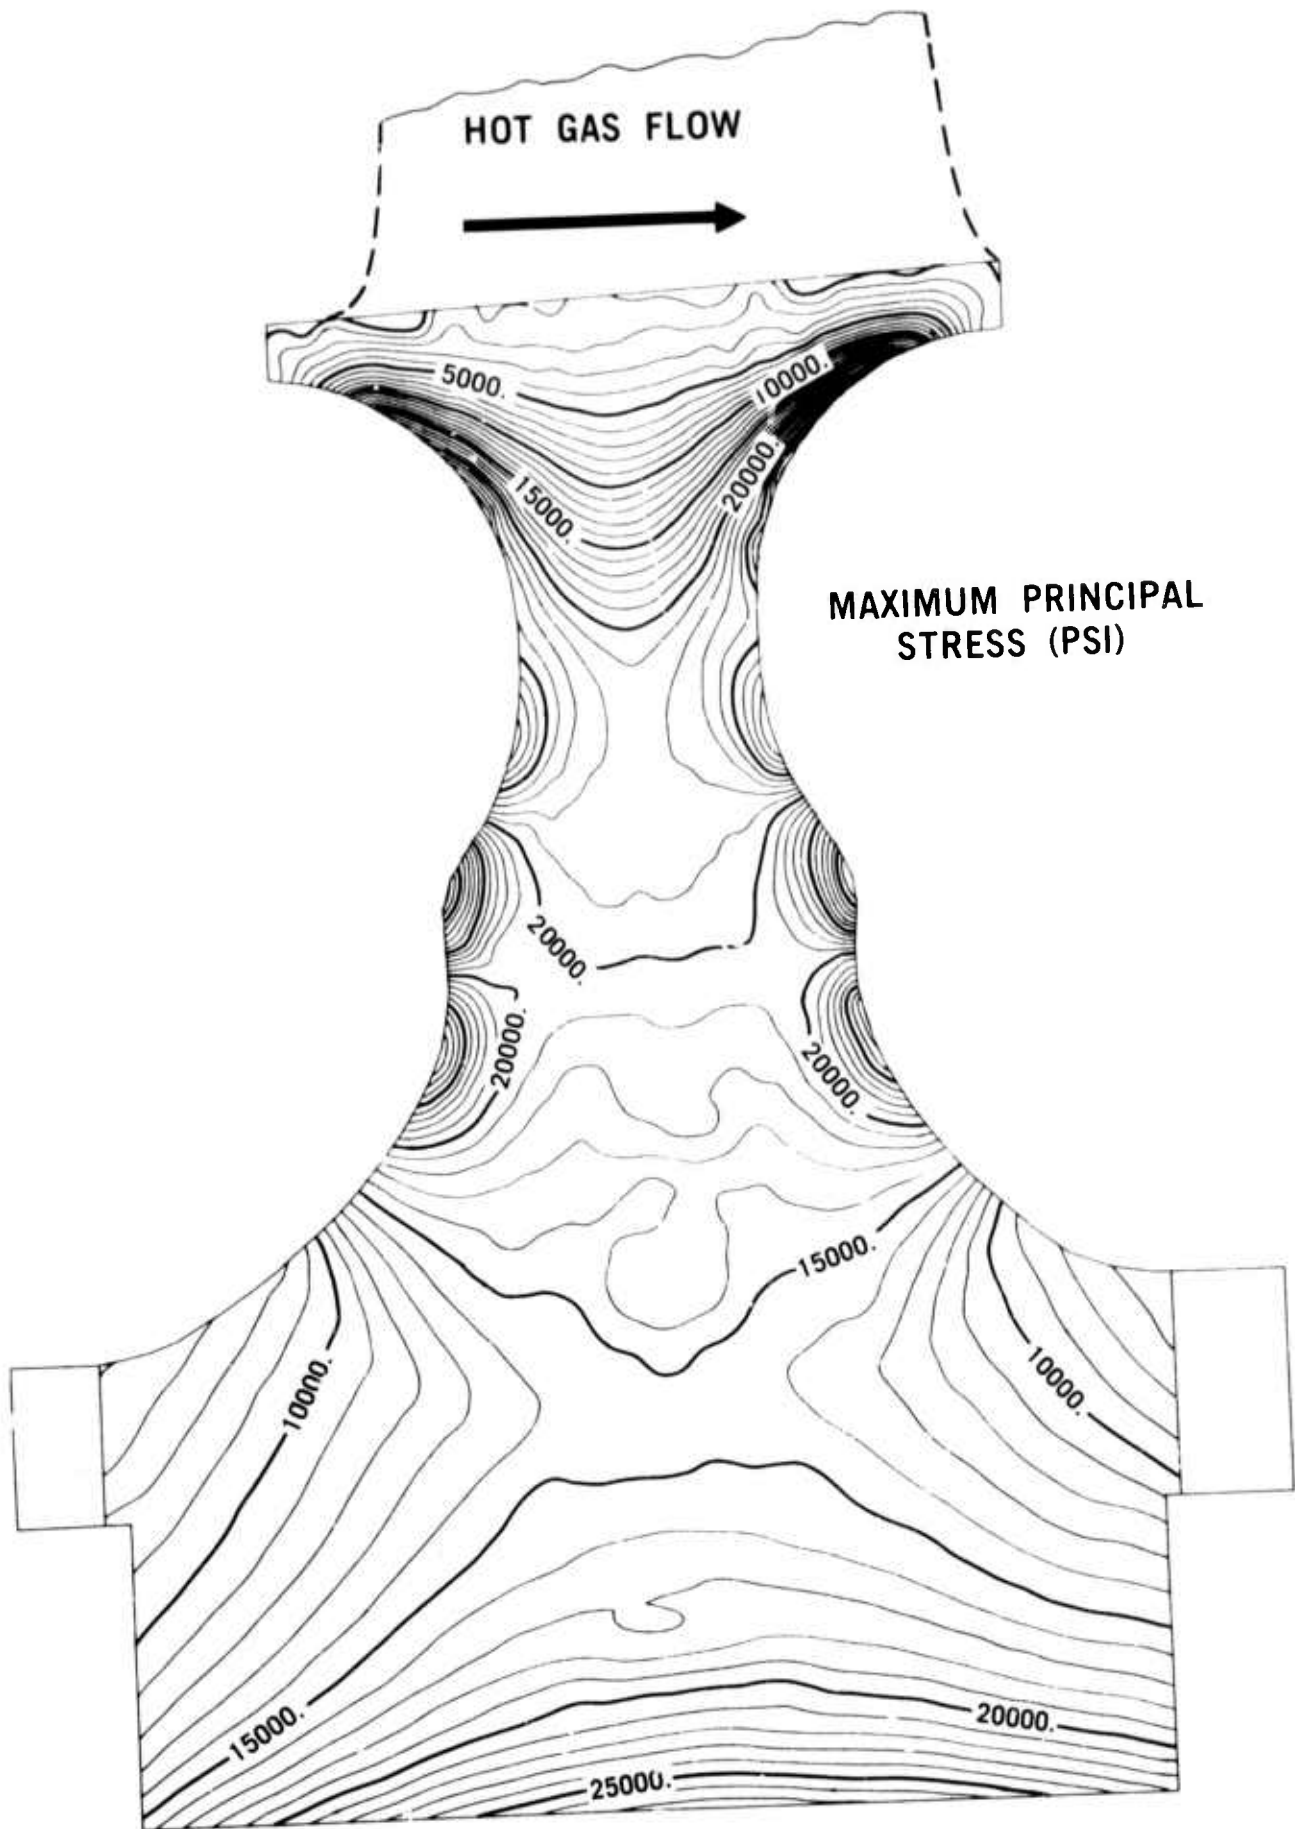
Figure 3.2b First Stage Rotor Stress Contour Map For The First Transient Condition

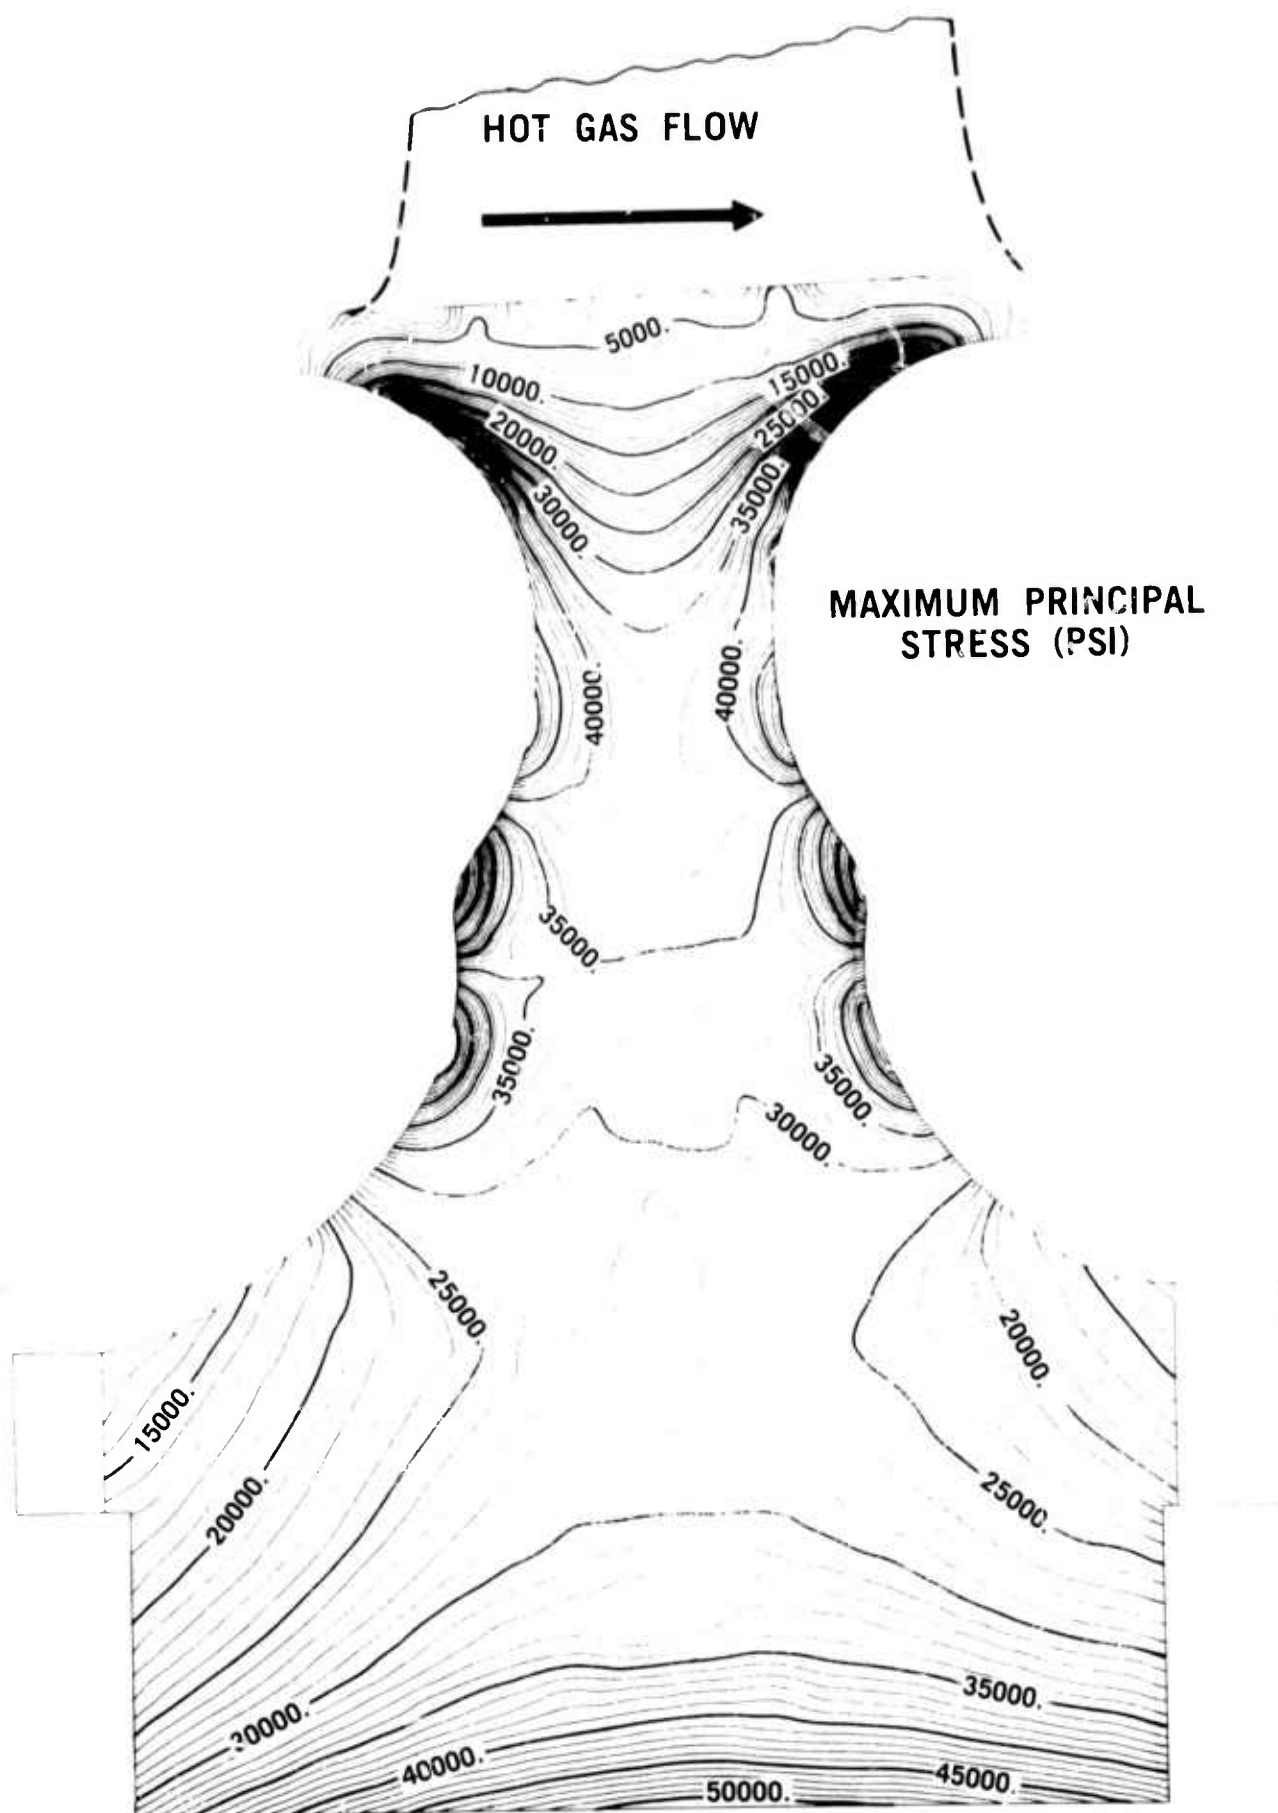
Figure 3.3b First Stage Rotor Stress Contour Map For The Second Transient Condition

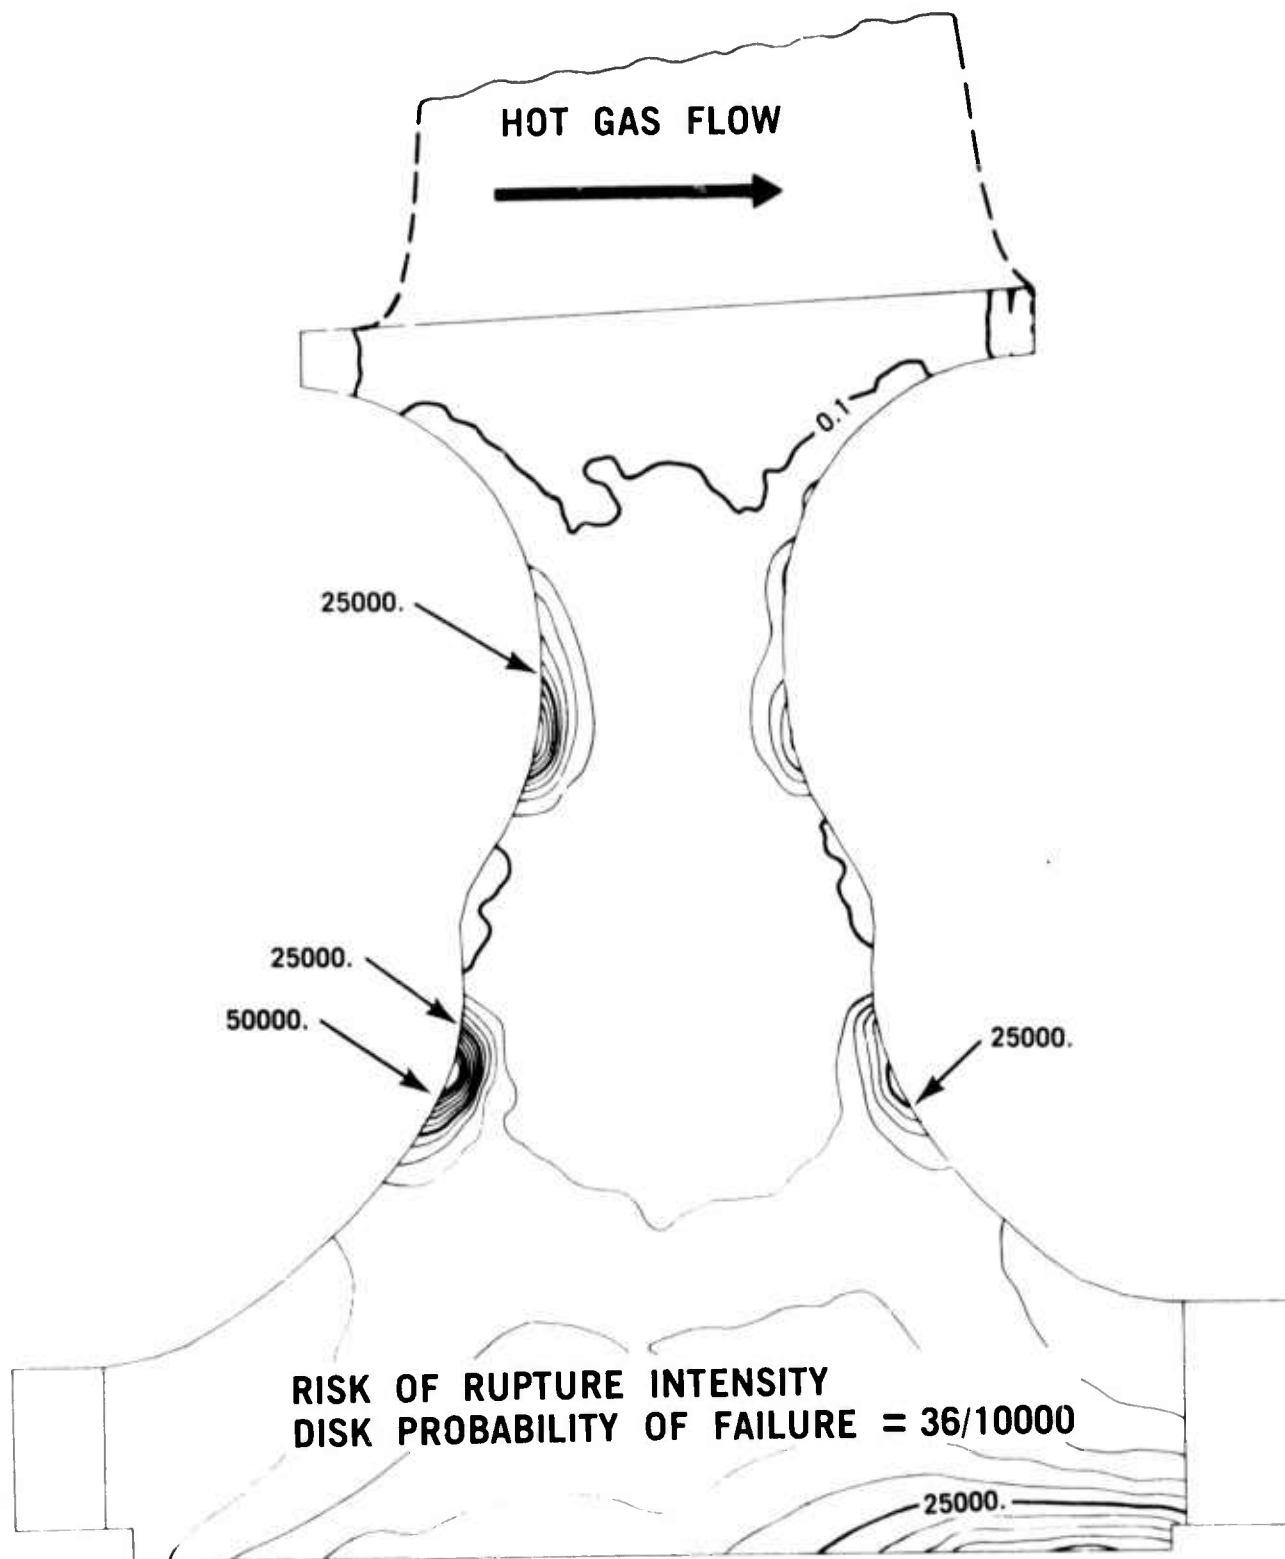
Figure 3.4 Modified Disk Contour First Stage Rotor Risk of Rupture Intensity Map For The Maximum Steady State Condition

With this in mind, a series of modifications were conducted on the basic disk contour of the first stage rotor, primarily in the areas where it appeared that the material was least effectively utilized, and the effect of these modifications on the risk of rupture intensity distribution and on the total probability of failure was evaluated. Some selected risk of rupture intensity distribution maps from this study are shown in Figures 3.4 and 3.5.

It is seen that a more uniform distribution of the risk of rupture intensity contour lines is obtained in the modified disk (Figures 3.4 and 3.5), as compared to the original one (Figures 3.1 and 3.3). This is evidenced by the increased density of contour lines in the bore region. Furthermore, it is seen that the risk of rupture in the stress concentration area immediately above the balancing ring has been greatly reduced.

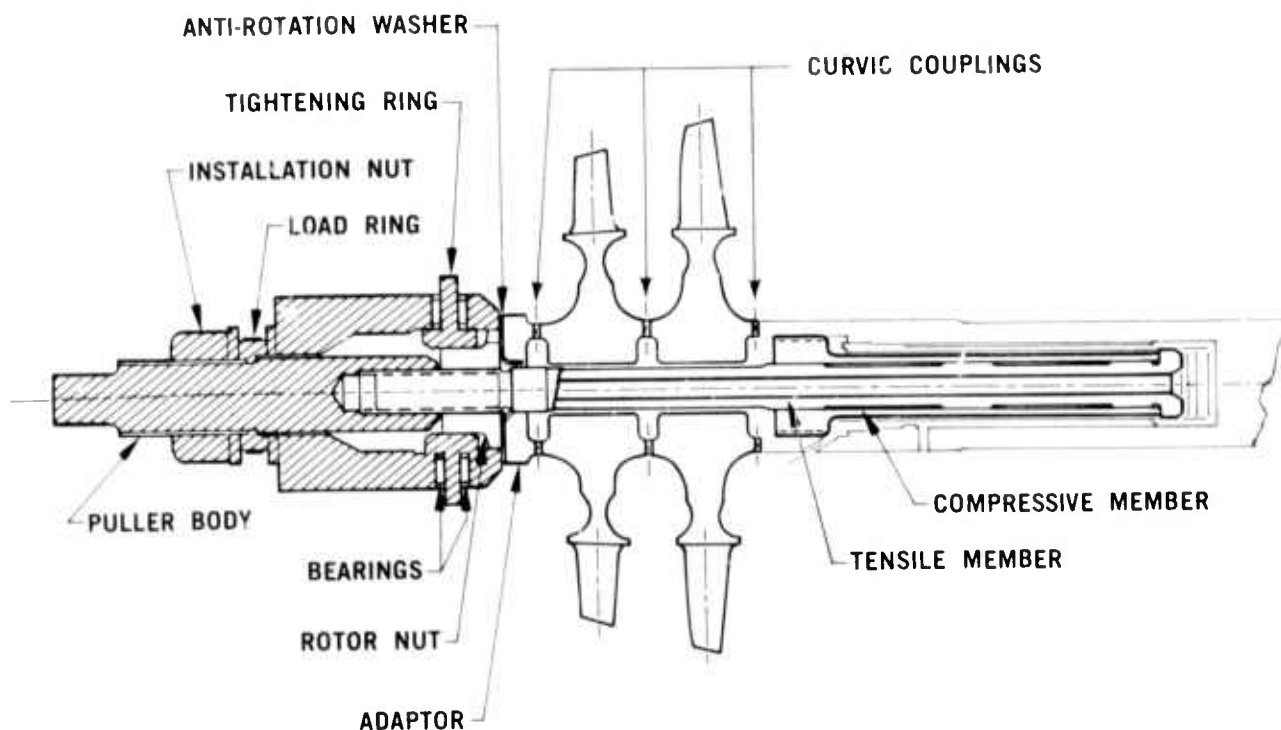
Figure 3.11 Turbine Rotor and Shaft Assembly Showing Installation Tool

Assembly is accomplished by placing the adaptor and the anti-rotation star washer on the shaft and tightening the rotor nut by hand. The installation tool is then threaded onto the bolt and, with the puller body held stationary, the installation nut is tightened to the correct preload. The load is measured with an aluminum load ring which has been strain-gaged and calibrated. The rotor nut is then tightened with the tightening ring until a small change in the load ring output is read. The installation nut can be removed along with the rest of the tool and the bolt will retain the desired preload. The rotor nut is locked in place by a star washer which engages both the nut and the

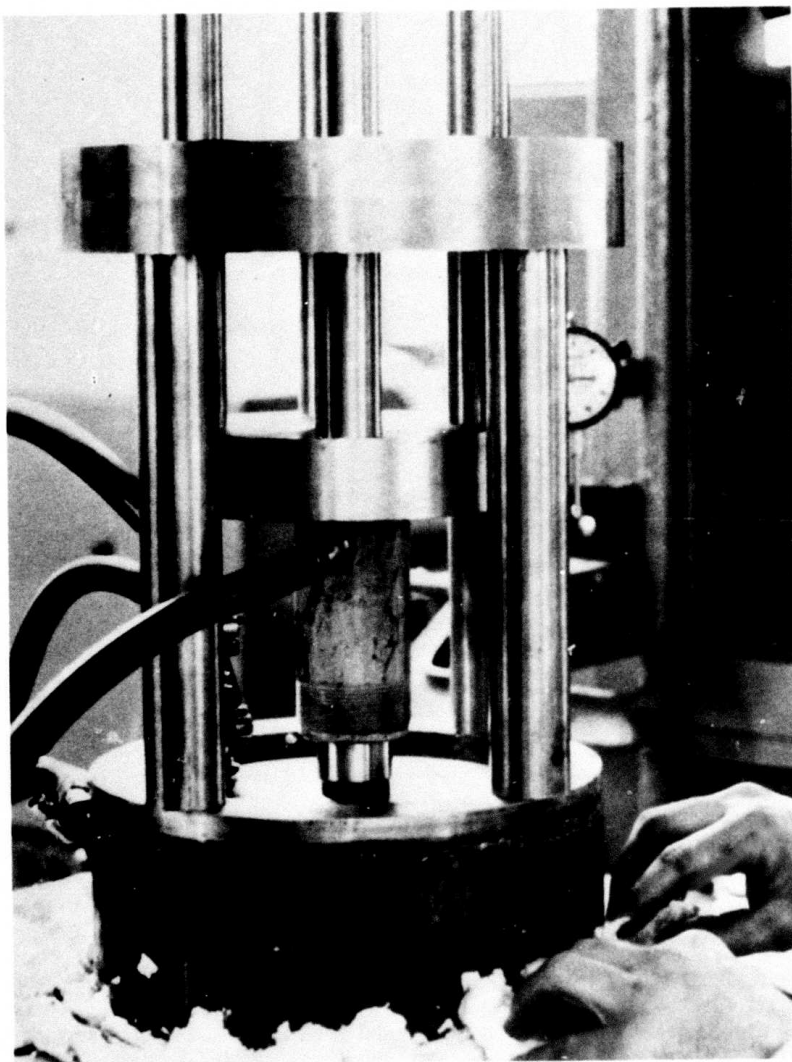
Figure 3.13 Stainless Steel Compression Rig

A stainless steel compression rig was designed and built to enable individual control and monitoring of the applied pressure on both the outside graphite wedge and inside hub component. The compression rig is shown in Figure 3.13. The large top plate transmits pressure from the top ram to the outside cooling ram while the small hand operated hydraulic piston exerts pressure to the center cooling ram. Figure 3.14 illustrates the graphite wedge system used in conjunction with the pressure application from the compression rig.

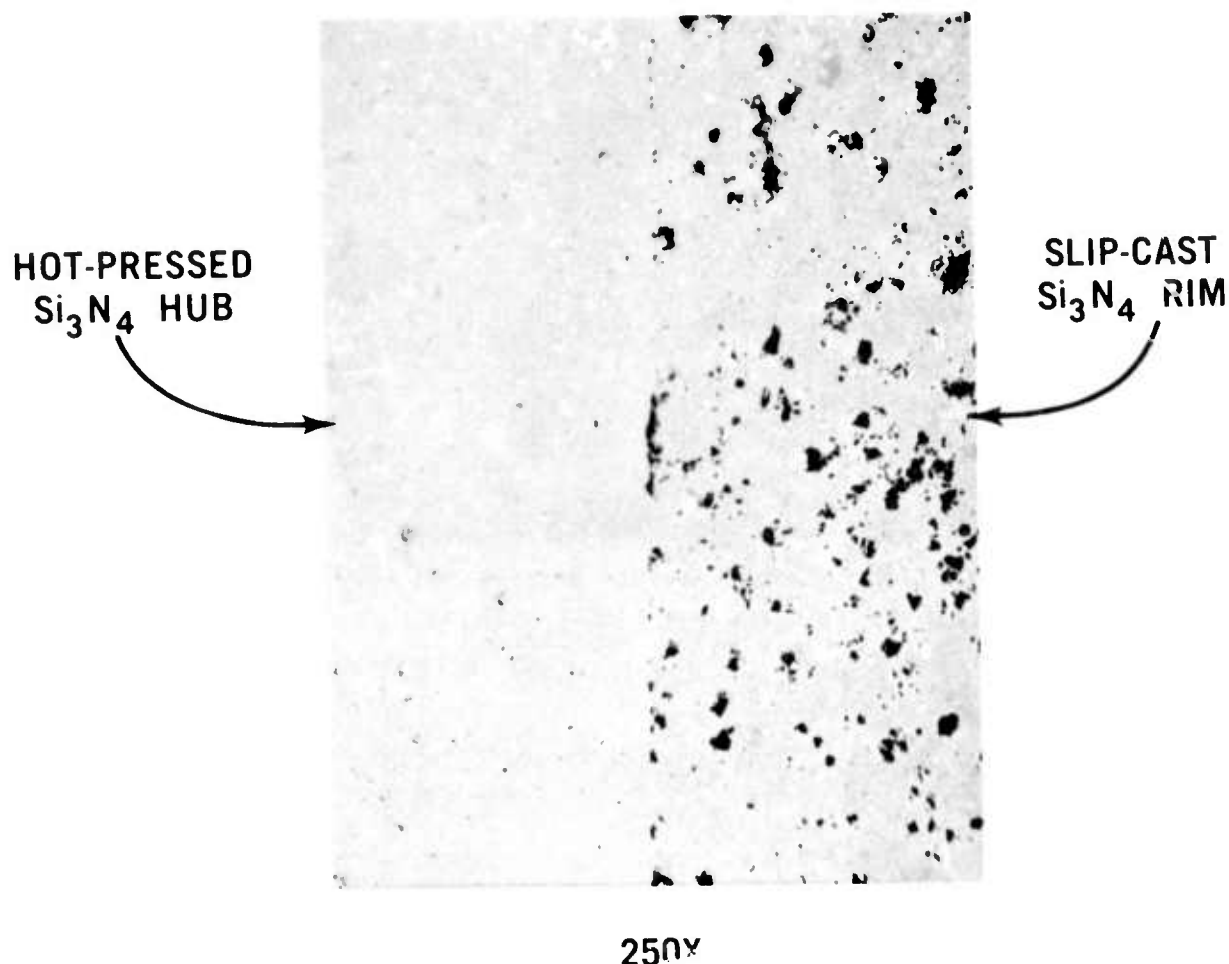
Figure 3.15 Microstructure at Between Hot-Pressed and Slip Cast Silicon Nitride (250X)

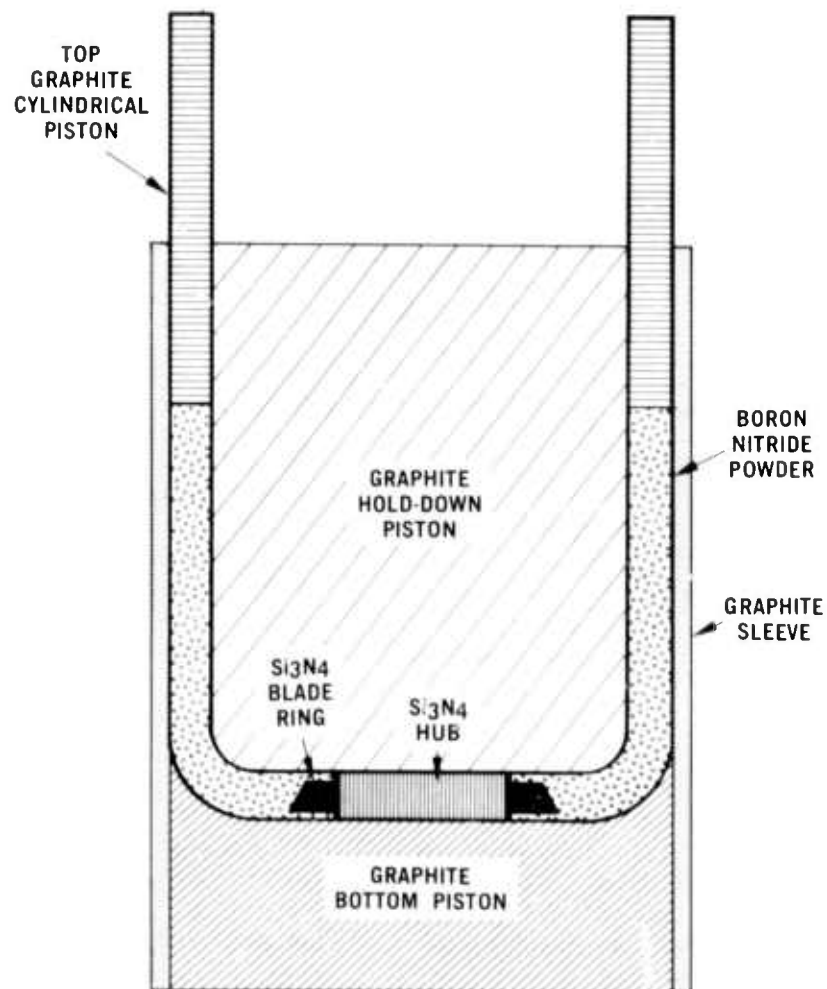
Figure 3.17 Die Design for Pseudo-Isostatic Fabrication Technique

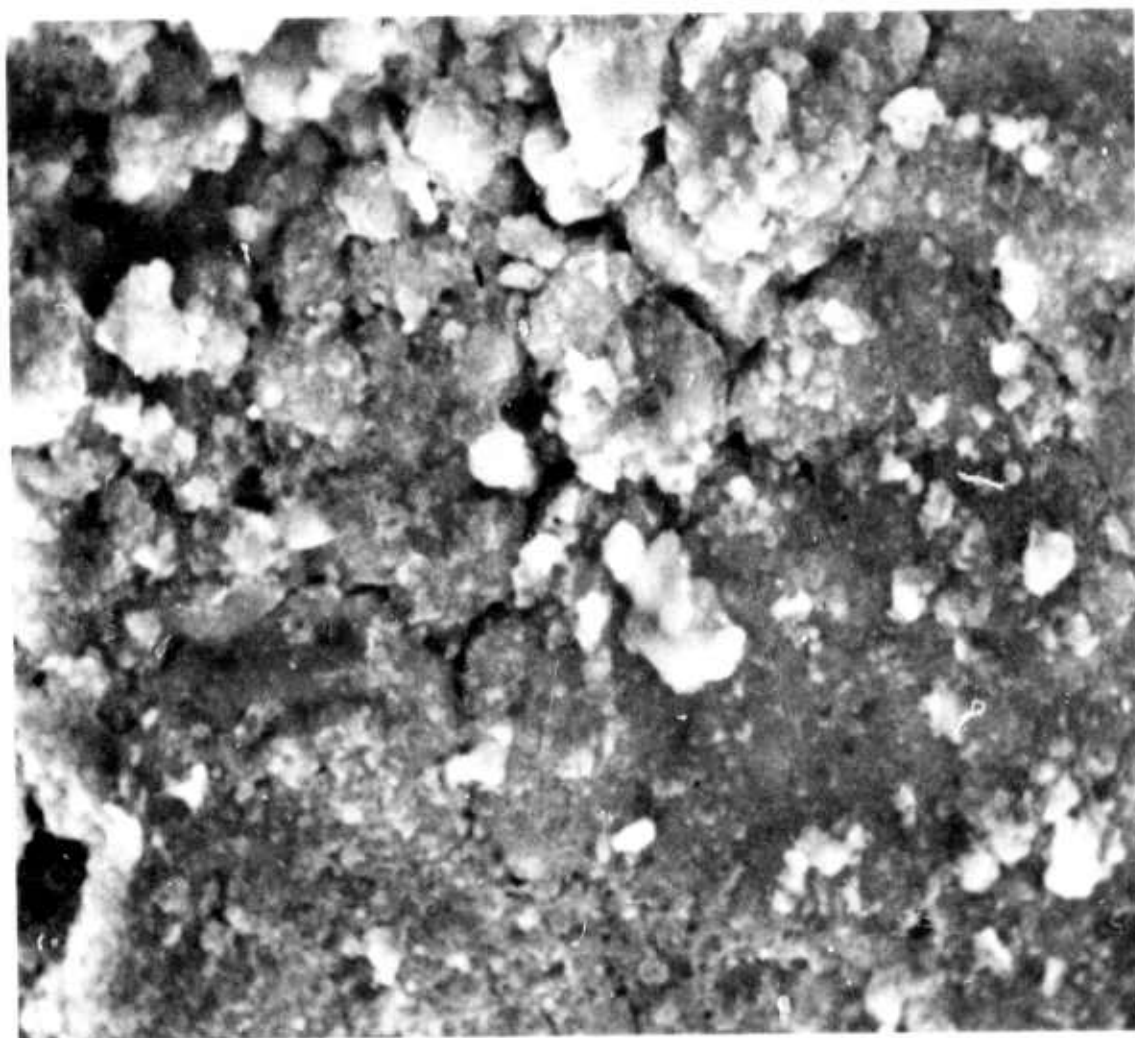
Figure 3.18 Scanning Electron Micrograph Showing Damage from EDM Evaluation of Silicon Carbide (750X)

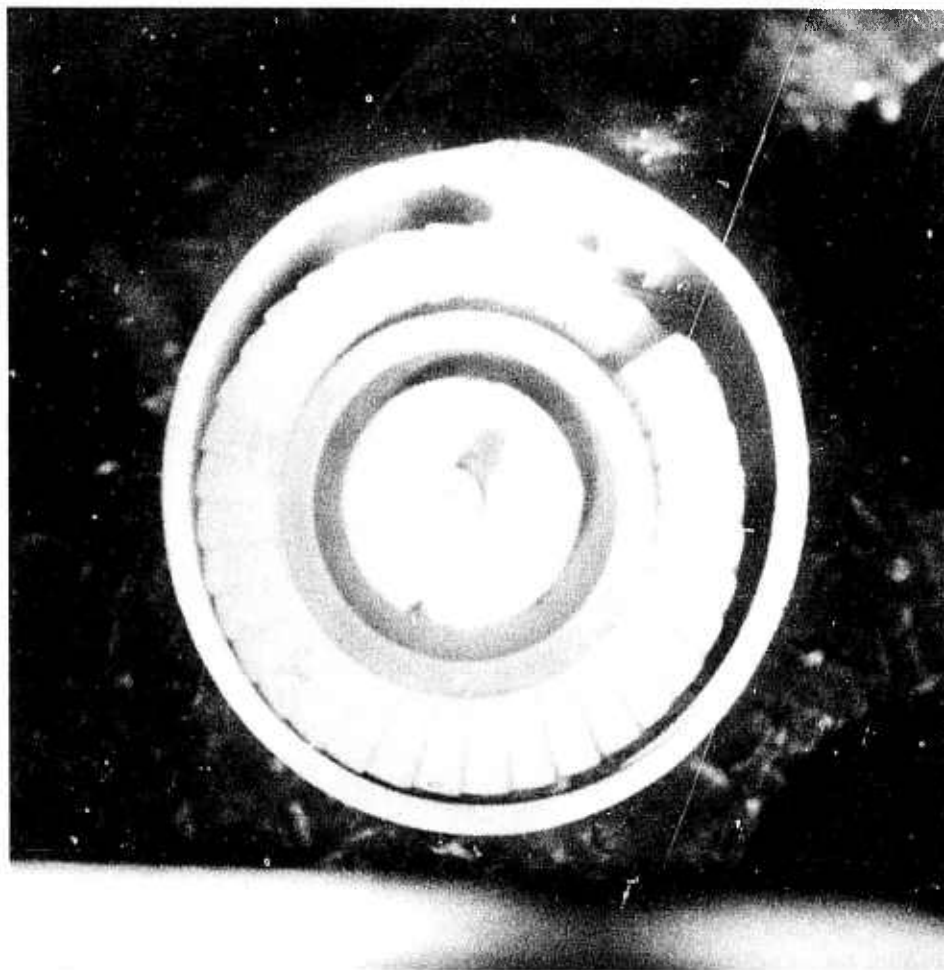
Figure 3.20 Triple-Density Rotor at Point of Failure (55,070 rpm)
During Spin Testing

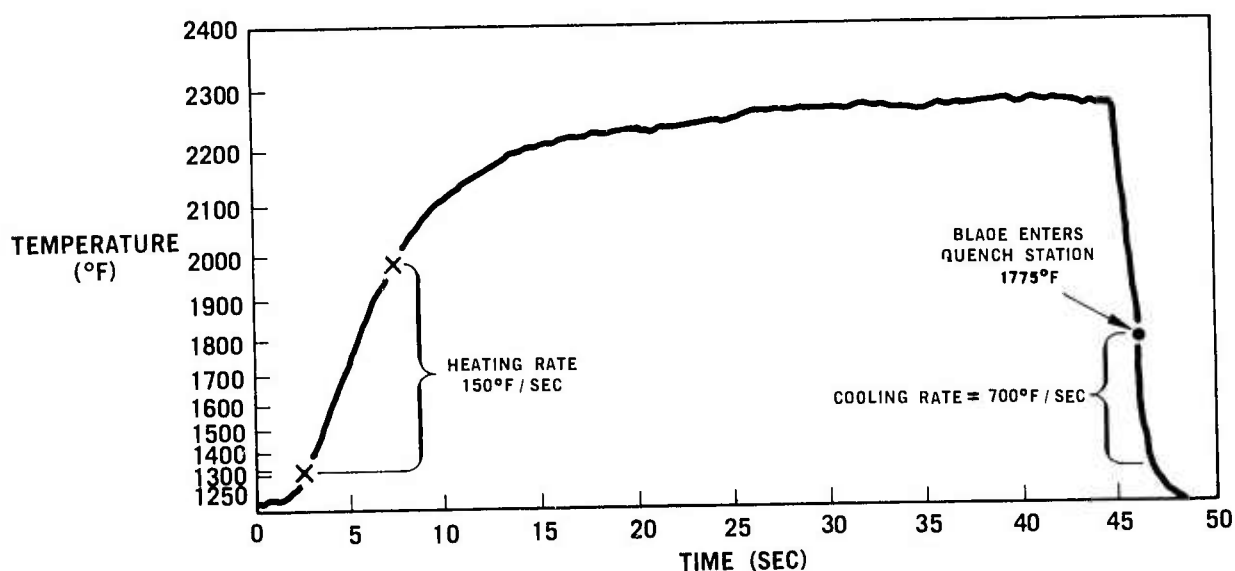
TEMPERATURE OF FLAME = 3000°F
 QUENCH AIR = 130 CFH
 POINT AT MIDSPAN LEADING EDGE
 THIS CURVE IS AN AVERAGE OF 3 RUNS

Figure 3.21 Thermal Shock Cycle

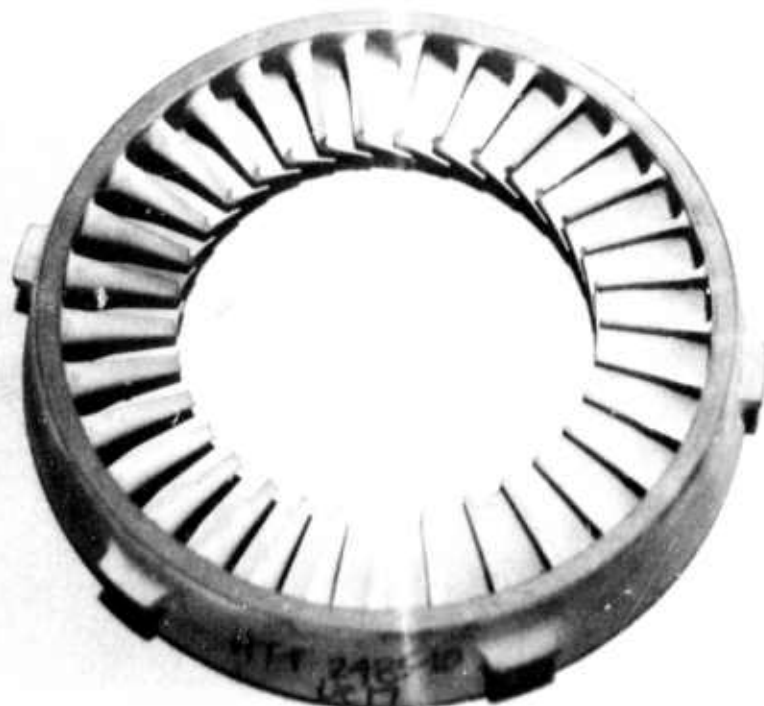
Figure 3.22 Second Stage Inverted Channel Stator Assembly

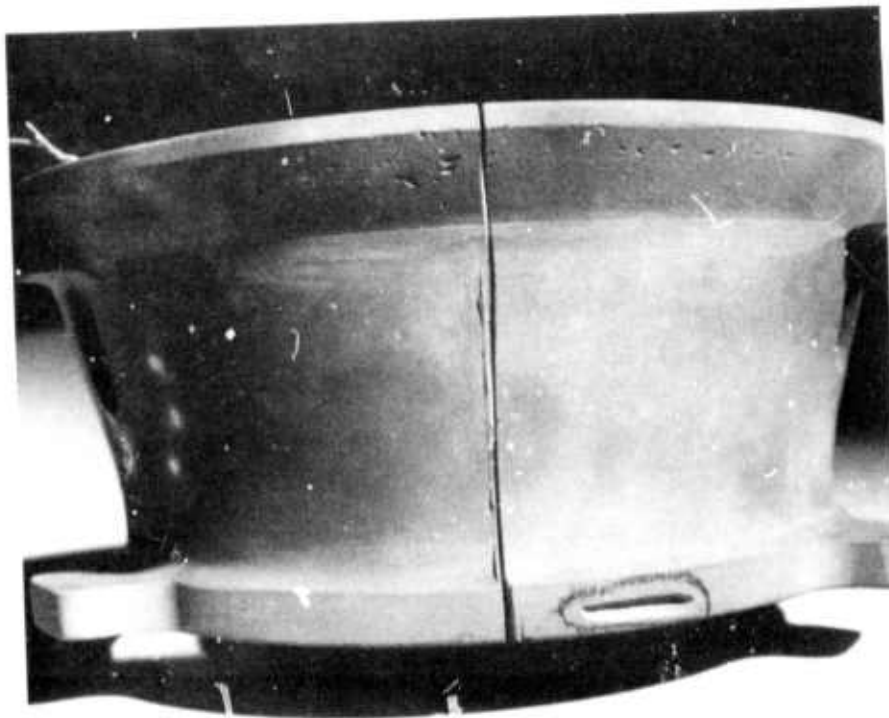
Figure 3.23 Nose Cone Illustrating Molding Flaws

described, consisting of section thickness reductions and pre-slotting of the nose cone outer shroud. During the processing of the redesigned nose cone, machining exposed internal flaws in the nose cone as shown in Figure 3.23. The flaws were mainly caused by uneven cooling shrinkage of the ceramic material in the tool. Selective heating of the tool was performed, using a hand-held heat gun in an attempt to minimize shrinkage. This technique was successful in controlling the solidification of the ceramic molding composition, thereby eliminating these internal voids. Provisions have been made to electrically heat various critical portions of the die, using automatic control, for future molding runs.

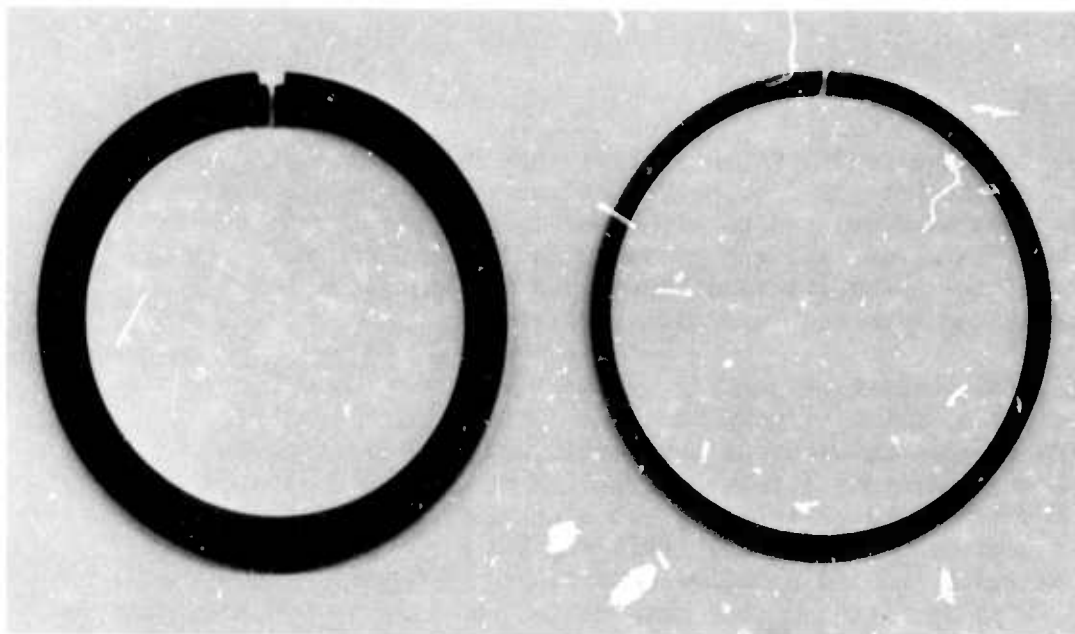
Figure 3.24 First and Second Stage Rotor Shroud Rings

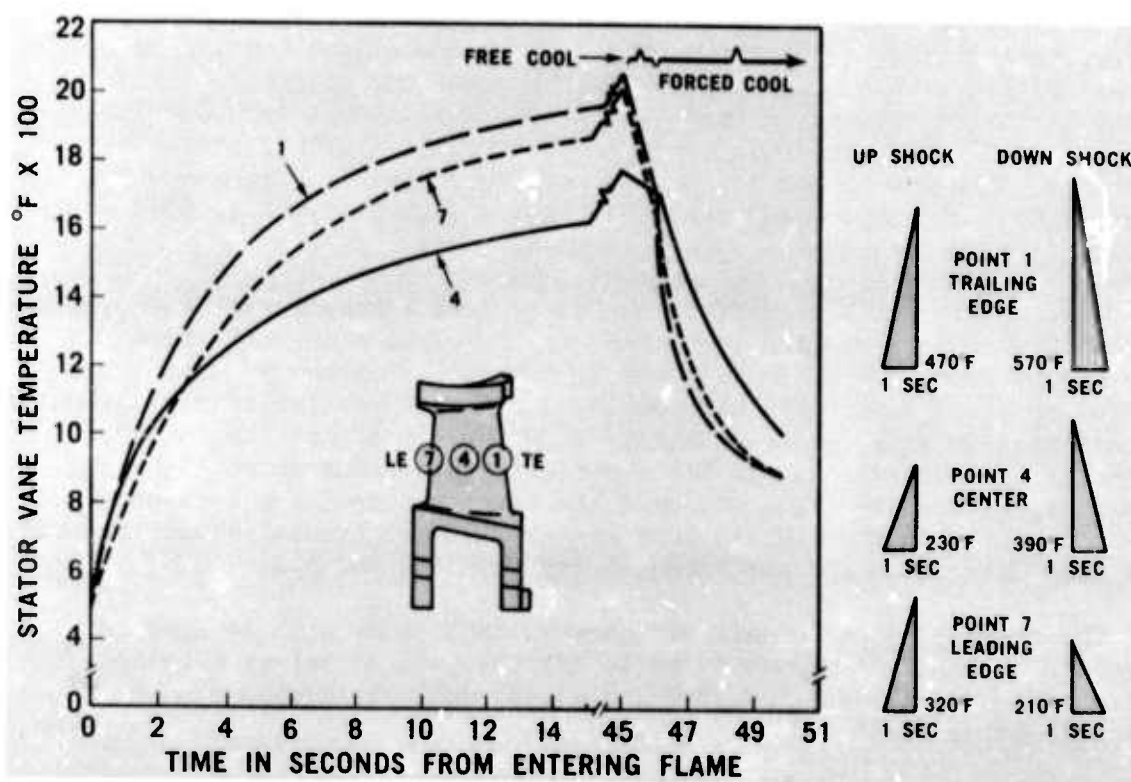
Figure 3.26 Heating and Cooling Behavior of First Stage Design C Stator Vanes on the Thermal Shock Rig

The predicted failure mode for stator vanes was tensile failure at the trailing edge on downshock. It was found by increasing the severity of the test that a cooling rate of more than 800°F/sec. at the midspan trailing edge was required to fail a Design C first stage stator vane. As shown in the next section, this cooling rate is significantly greater than that encountered in engine operation. Thus, the faster cooling rate of the thermal shock test rig permitted downshock testing under more extreme conditions than would be expected during engine operation.

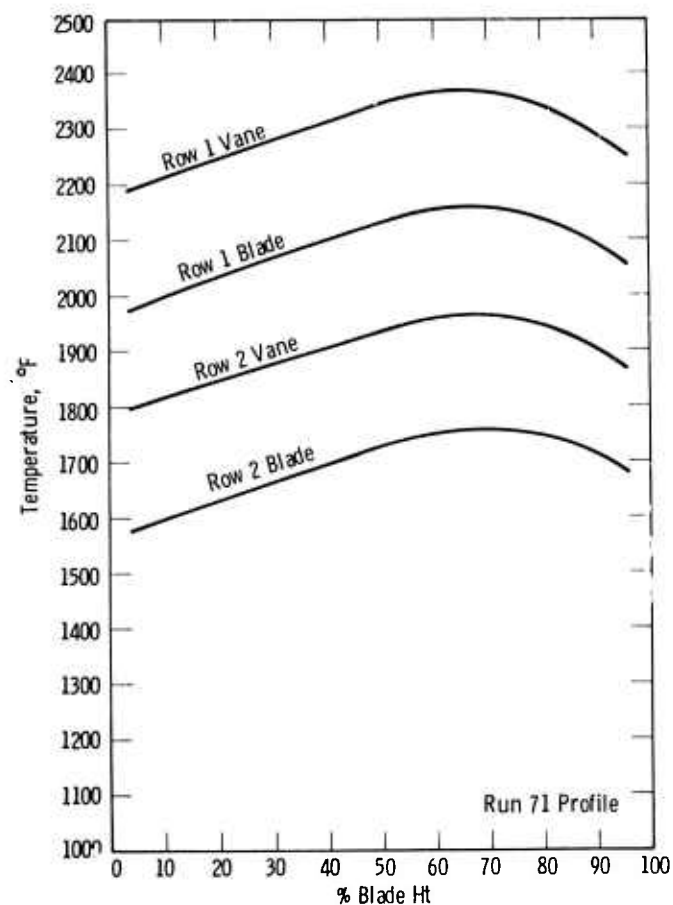
Figure 4.2 Calculated Gas Temperatures at Various Stage Locations in the Power Turbine for 2300°F Turbine Inlet Conditions

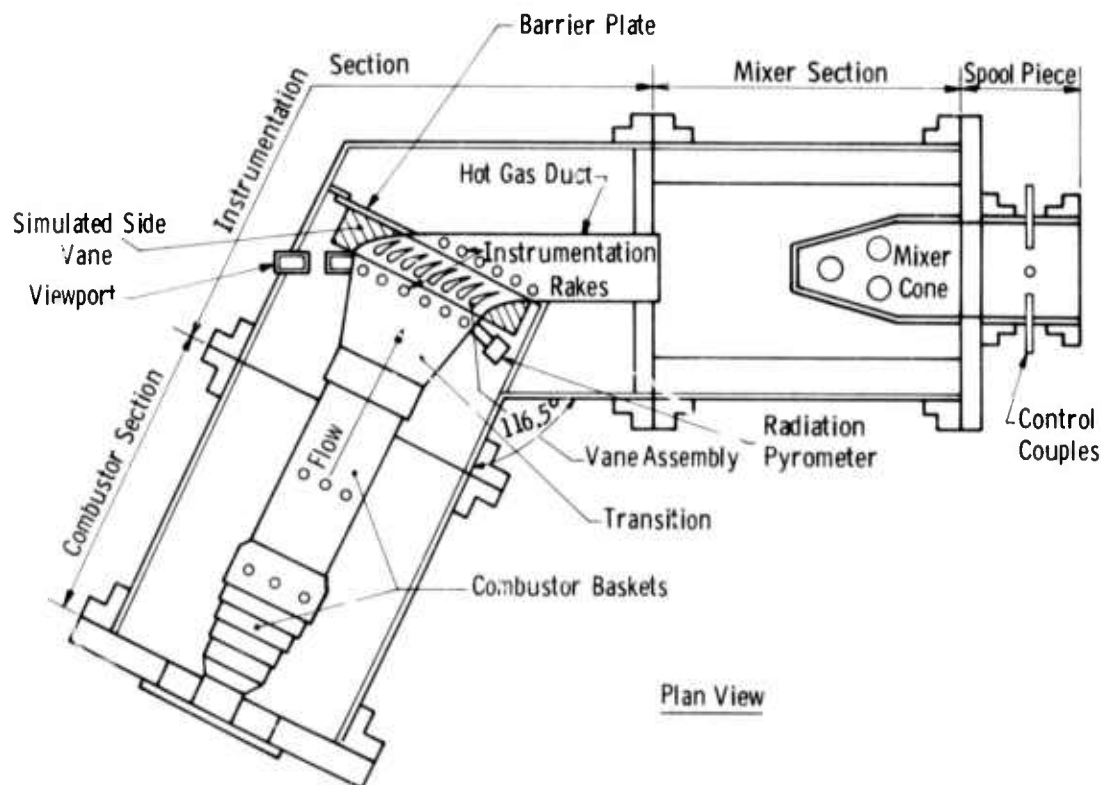
Figure 4.6 Schematic of Static Rig for 2200°F Test of Ceramic Vanes

A plane view of the static test rig is given in Fig. 4.6. This facility was designed and constructed specifically to create an environment identical to that of a gas turbine. Ceramic vane assemblies are tested in their true radial configuration and actually perform a gas turning

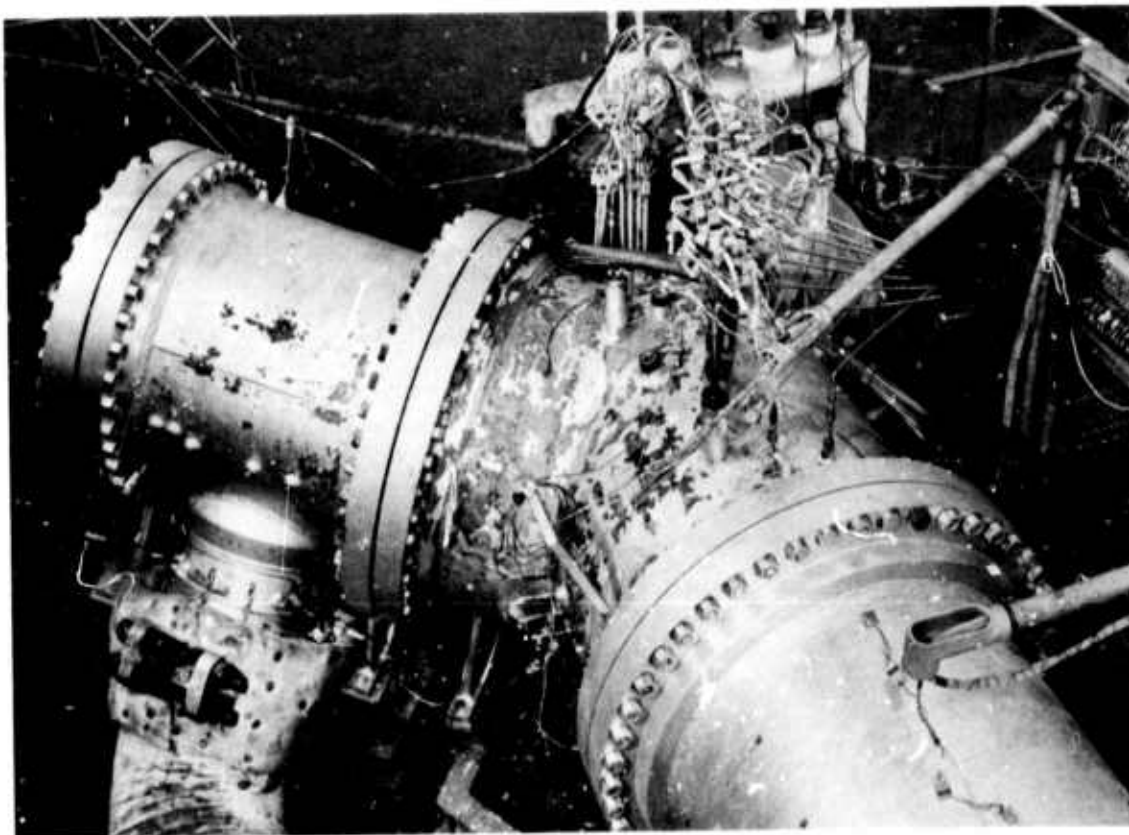
Figure 4.7 Exterior View of Static Test Rig
